ESTCP Cost and Performance Report

Innovative Acoustic Sensor Technologies for Leak Detection in Challenging Pipe Types

December 2016

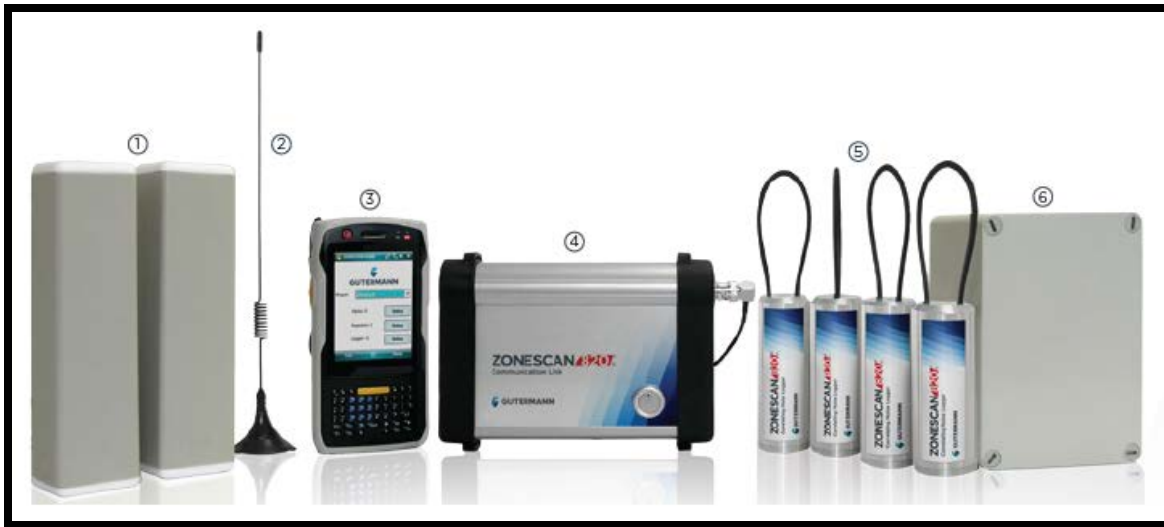
The ZoneScan Alpha acoustic logger sensor system for continuous monitoring is shown in Figure 2.2. Table 2.2 summarizes the primary components, along with their respective function. System components include: (1) radio repeater modules to send data to a centralized computer processing system; (2) extended antenna (optional to transmit data over longer distances); (3) personal data assistant (PDA) for system setup; (4) communication link for system setup;

(5) ZoneScan acoustic sensors; and (6) ZoneScan Alpha Com Link. The system also relies on data management, processing and display capabilities provided by a personal computer system operated by the user and Gutermann's centralized server that provides data processing capability. The sensors are permanently or temporarily installed on valves or fire hydrants at targeted areas of the potable water distribution system. The sensors are easily attached via a magnet on the bottom of each sensor. The sensors can be connected via radio transmission or they can be integrated into an existing AMI network.

Figure 2.2. ZoneScan Alpha System Components (Courtesy of Gutermann)

Note: See Table 2.2 for definition of system elements

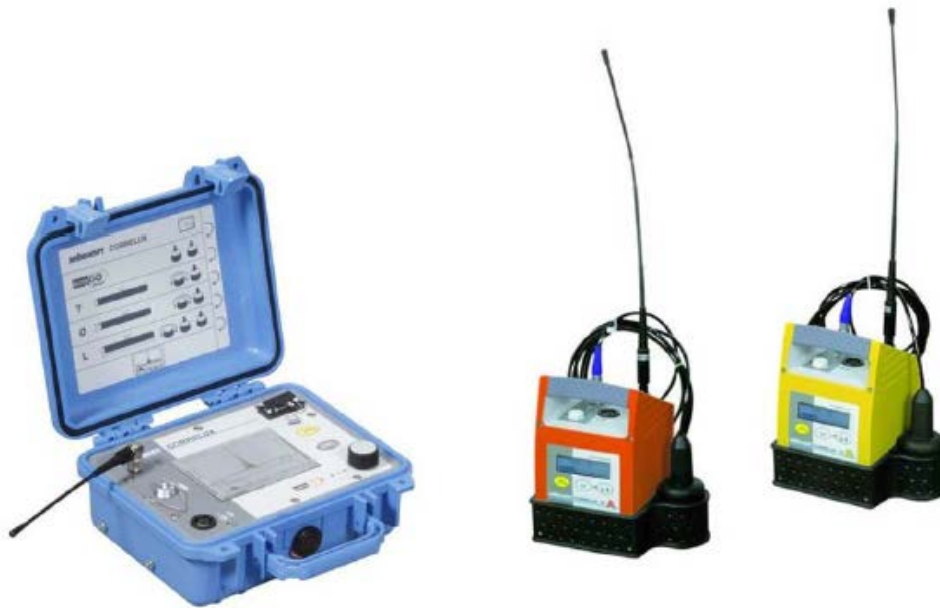
The Correlux HL6000X is a correlator system used for automatically pinpointing leaks in water pipes (see Figure 2.5). It consists of two radio transmitters that connect to piezo-ceramic accelerometers (transmitter A and B), the correlator (the user interface device), correlation software, and headphones. The correlator device can be connected to a personal computer for software updates, downloading data, and to printout results. The correlator device has enough memory to record data for up to 10 segments. It is powered by a battery with an operational life of 12 hrs. Each radio transmitter is powered by an internal battery with an operational life of 15 hrs. All devices can also be externally powered using a 12-volt direct current car adapter or 110-volt alternating current power supply.

Figure 2.5. Correlux HL6000X System (Courtesy of Vivax-Metrotech)

The correlator system works by placing the two accelerometers (sensors) at either end of a pipe section (on valves, exposed pipe sections, or hydrants as the local conditions dictates). Table 2.6 shows the recommended sensor spacing based upon pipe type. The sensor spacing must be accurately measured for input into the correlator if a leak is detected. No information was available on a minimum detectable leak size or typical location accuracy of the Correlux system.

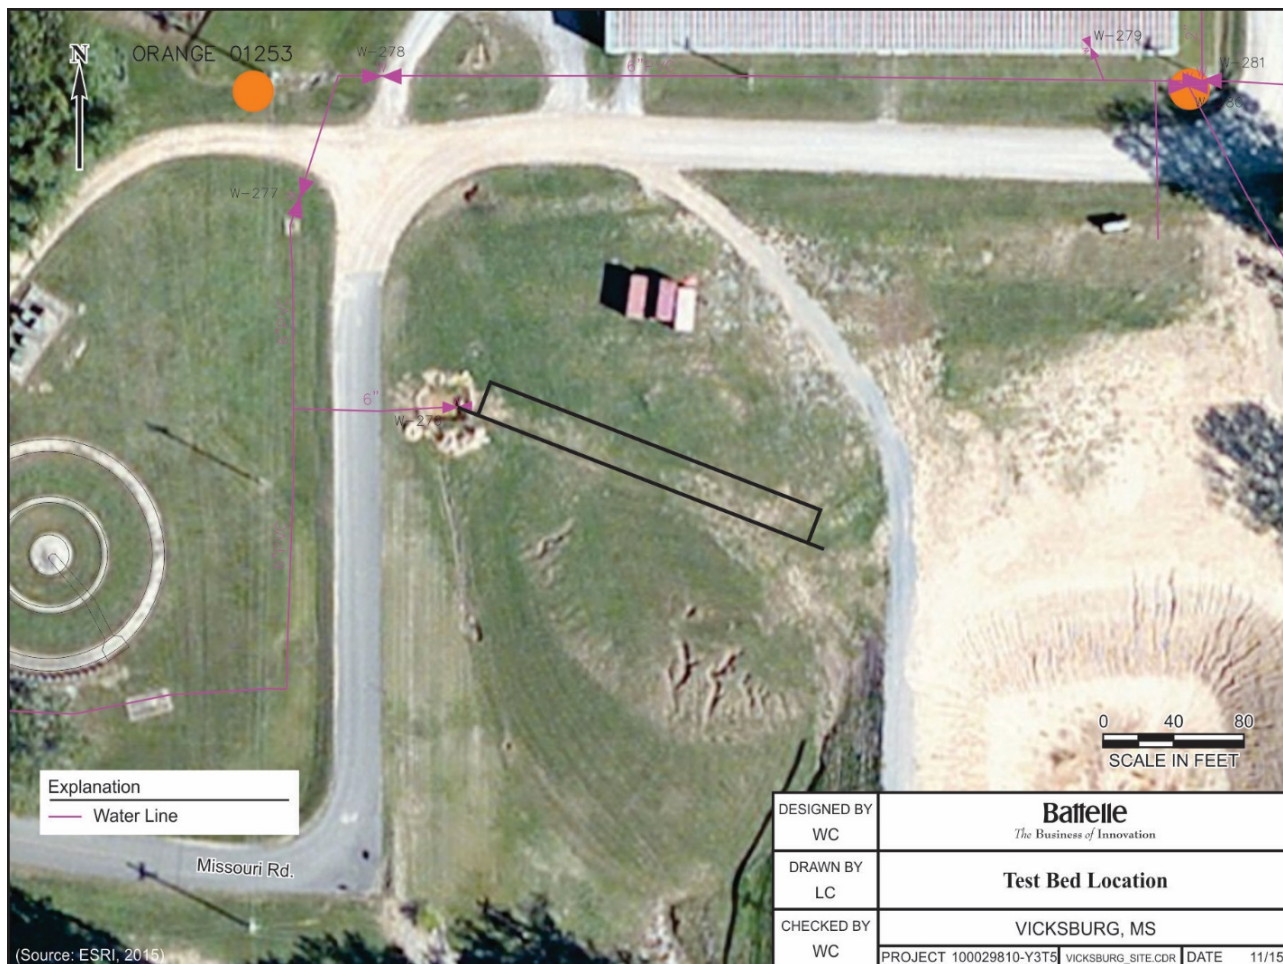
A 200-foot TB was constructed for use in the project, which was located in the northeastern corner of the ERDC campus (see Figure 4.2). It was previously used as part of a hydraulic testing facility with a 6-inch PVC water supply line leading to a large surface impoundment. The TB consisted of 90 ft of 6-inch DI pipe and 110 ft of 6-inch PVC pipe. Risers were installed on the test sections to allow for the placement of the acoustic sensors including accelerometers and hydrophones. After TB construction, 10 simulated leak locations were installed on the main line, along with one simulated leak on a nearby PVC lateral line. The 11 total simulated leaks were established using corporation valves and orifice plates with openings of various diameters (as discussed in Section 5.0).

Figure 4.2. Test Bed (TB) Site Location

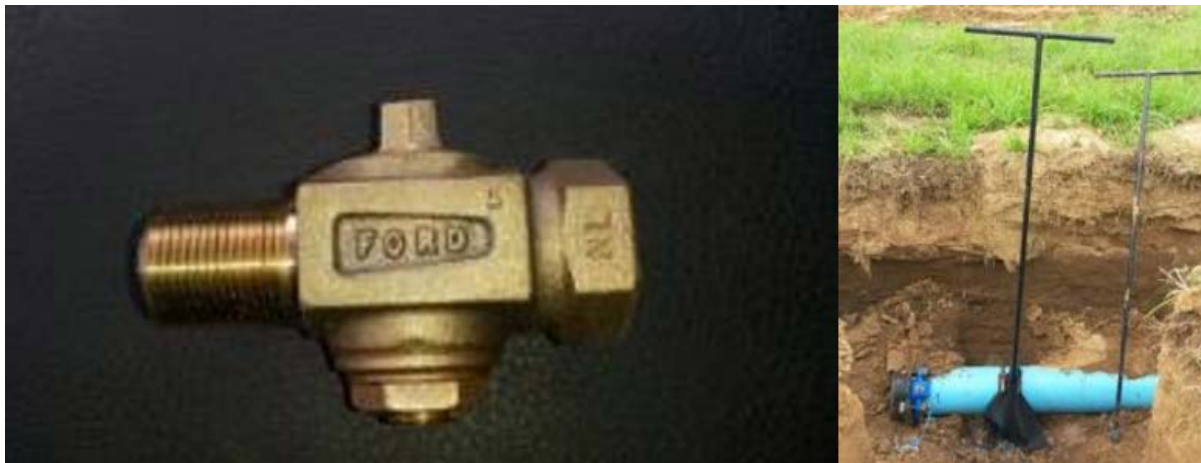
Figure 5.2. Simulated Leak Configuration Using Corporation Valves
